## Case Study 05 Hong Kong Building Exteriors and Railings

High Urban Pollution

High to Moderate Coastal Salt Exposure

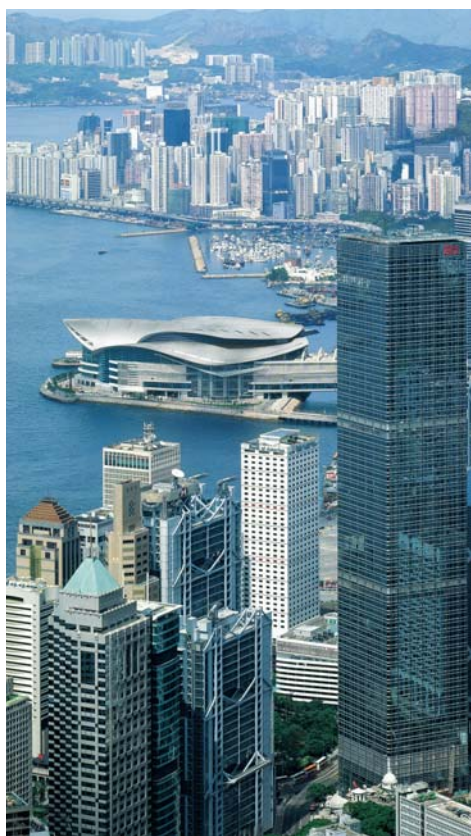
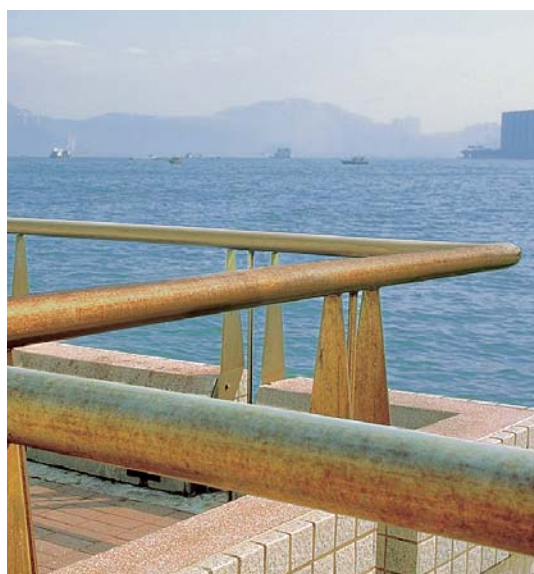
Hong Kong's 63-story, Cheung Kong Center was completed in 1999. The exterior is glass and Type 316 (UNS S31600, EN 1.4401, SUS 316) stainless steel. Type 316 stainless steel contains 2% molybdenum, which improves resistance to corrosion caused by pollution and salt. **(Figures A and B)** The building is less than 1.6 km (1 mile) but more than 30 m (100 ft) from the harbor. It is exposed to sea salt in the air and rain but not salt spray. Both a coined HyClad Cambric and a fine No. 4 finish were used on the exterior. Rain and regular maintenance cleaning remove the corrosive contaminants and dirt from these smooth finishes. Cheung Kong Center was designed collaboratively by the architecture firms Cesar Pelli, Leo A. Daly, and Hsin-Yieh and has retained its original attractive appearance.

**Figure A and B** Cheung Kong Center is the high-rise building in the foreground of Figure A. The entrance and other details are visible in Figure B. Type 316 stainless steel with smooth surface finishes was an excellent choice because it is exposed to pollution and coastal salt. Window washing tracks were built into the building for easy cleaning. As shown in Figure A, it is in close proximity to the harbor. (Photos Courtesy of Outokumpu)
